INFORMATION REPORT

| SUBJECT | Pács Airfield | DATE DISTR. | 22 April 1953 | |

Annex A: Memory sketch of the Pács airfield, Hungary

Memory Sketch of the Peas Airfield, Hungary

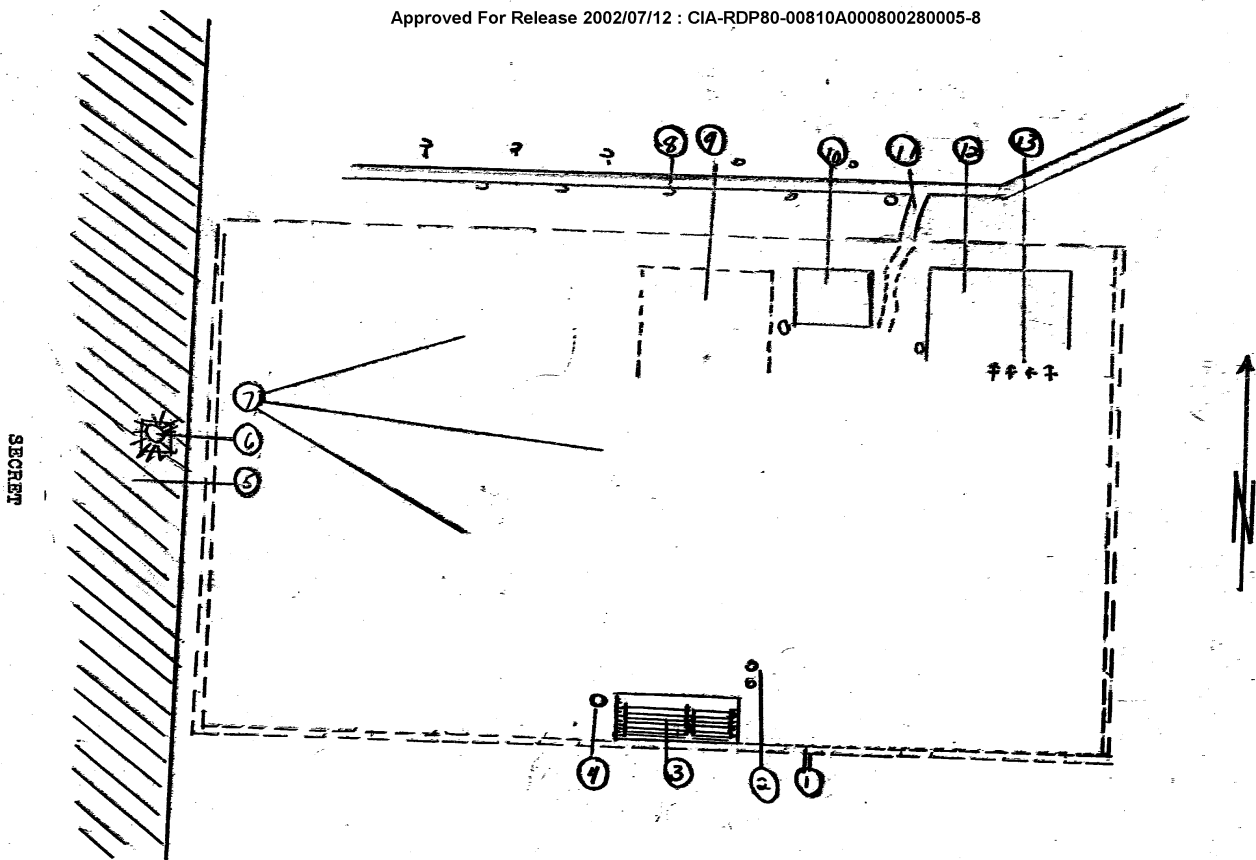
1. Boundary Lights. The airfield had no physical boundary fences. Boundary lights were used to outline the landing position of the field at night and act as daylight boundary markers. These built-in lights were covered with red-stained glass and set on the ground extending only along the east, south and west sides, 2 m. x 50 cm. x 50 cm.

2. Guards. Two political policemen patrol the boundary at night only, armed with rifles.
3. Grandstand, old and deteriorated - not used. Field was a horse race track at one time.

4. Guards, three political policemen, equipped with rifles.
5. Pecs Suburb. Airfield boundary line 10-15 m. from edge of town. Small single story family dwellings in this section. No obstacle.

6. Beacon. It appeared not to rotate, light was red. Structure was of brick first five meters, the rest steel structure. Total height 30 m. Light could be seen easily from opposite edge of town. Beacon located about one-half kilometer west of field in Pecs suburb.

7. Field, all sod. When aircraft landed tracks could be seen in grass. Field appeared level, with no obstacles in vicinity.
8. Road, secondary, cobblestone, six meters wide, lined with deciduous trees.

9. Hangar Foundation, bombed out during World War II.
10. Building, one story, brick construction, hipped tile roof, 30 x 10 x 16 m, used as offices. Building appears to be old.

11. Driveway, crushed rock, four meters wide, with walk along the right side.
12. Hangar, concrete reinforced, flat deck roof, 30 x 20 x 10 m. Sliding type doors. Incoming aircraft would park in front of this hangar.

13. Aircraft. I noticed one or two bi-winged courier-type aircraft, AN-2, land almost daily; these would normally not remain overnight. Also I noticed one or two civil planes, LI-2, per day, some of which remained overnight. I did not notice markings.
